Bus Safety Study: A Report to Congress

FTA Report No. 0051
Federal Transit Administration

Center for Urban Transportation Research
University of South Florida

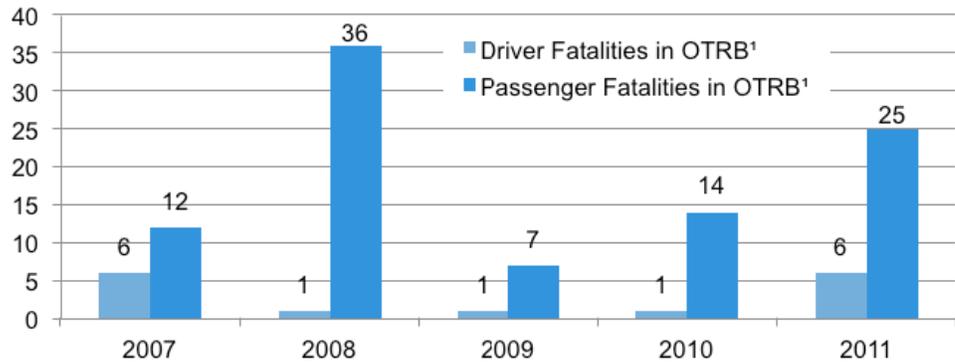
Figure 1

OTRB Driver and Passenger Fatalities on High Speed Roadways²

²High speed roadway defined as location where speed limit is greater than 45 mph.

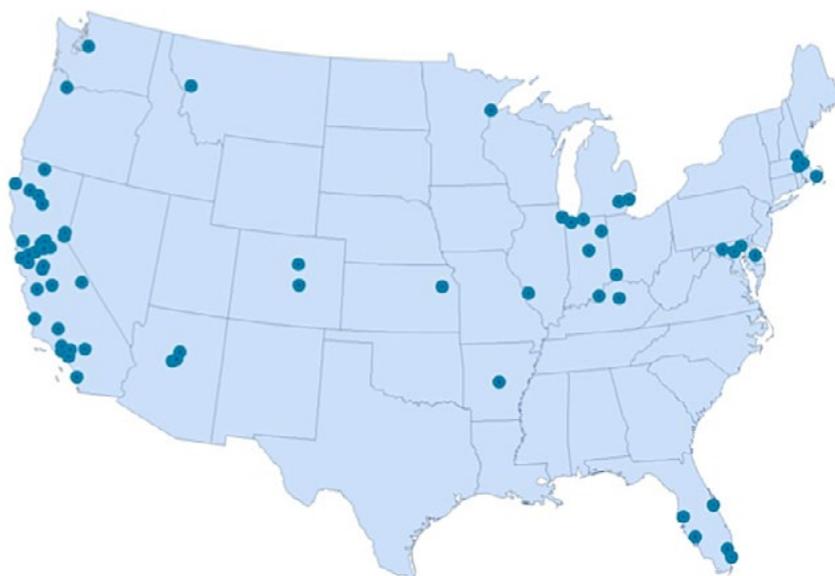
Figure 2-1
GTFS Reporting Agencies

Using U.S. Census TIGER line files and the GTFS data from U.S. transit agencies, the study team identified and calculated the distance that transit routes operate on highway segments. Using scheduled trip information from the GTFS files, the total route miles were calculated for each agency. Figure 2-1 identifies the locations of those public transit agencies that release GTFS data and are included in this analysis.

The study team identified 243 transit agencies with GTFS data. A total of 99 of the agencies were removed due to data inconsistencies and/or the fact that the GTFS represented non-roadway modes such as commuter rail or ferry. Others were eliminated due to long processing times resulting in a final total of 70 agencies for which calculations were made.
